ENGINEERING CASE LIBRARY

SPONTANEOUS FRACTURE (A)

FAILURE OF HEADWEAR HOLDERS

Owl Equipment Ltd.
Helen, Ontario

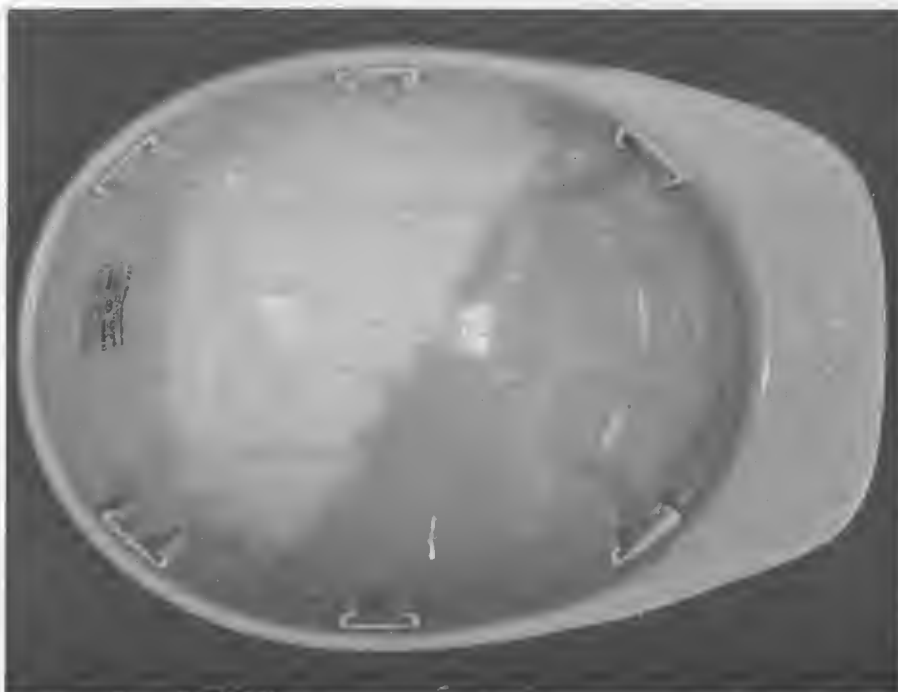
Figure 4

Owl Equipment had recently received a rash of warranty claims on helmets. The harness holders in the hat were failing. From the examination of the returned hats Mr. Lami and Mr. Bowan concluded that the majority of failures were in the right side holder, (Figures 4, 5, and 6) although failures were not exclusively confined to this holder. Failures had occurred in other holders but not to the extent as in the right side holder.

HARD HAT WITH HARNESS REMOVED

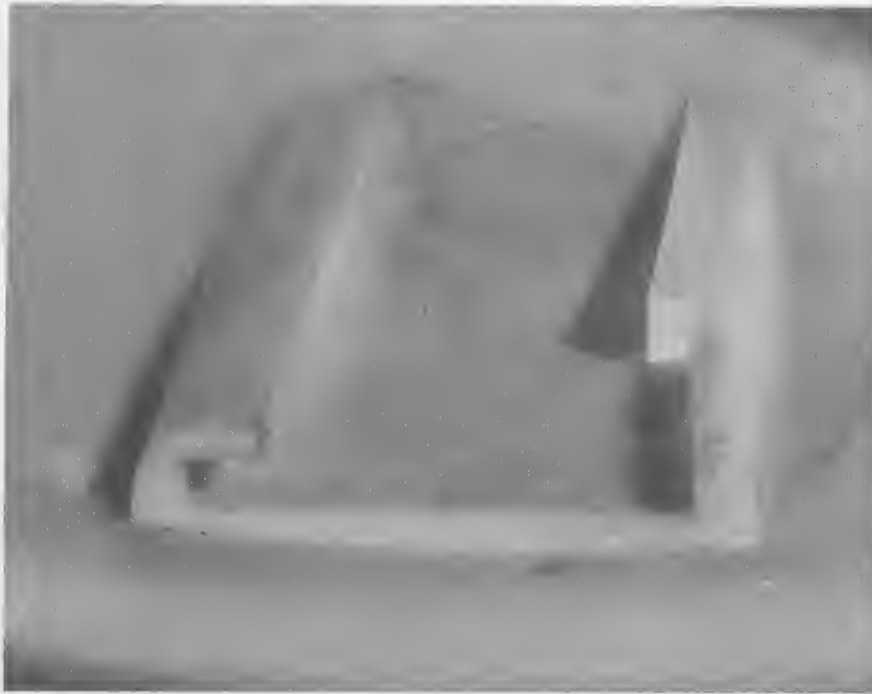
Figure 5

The fracture surfaces showed typical brittle fracture (Figures 5 and 6). An attempt to reproduce this type of failure by pulling on the ears of the holder was unsuccessful. The ears of the holder could be bent through a large angle without fracture. When failure occurred a stringy torn surface was produced. The surface produced by overloading had no resemblance to the brittle fracture due to service failure. The nature of the failure surface would lead one to suspect fatigue in a metal but this was plastic and there was no cyclic loading.

BROKEN HARNESS HOLDER

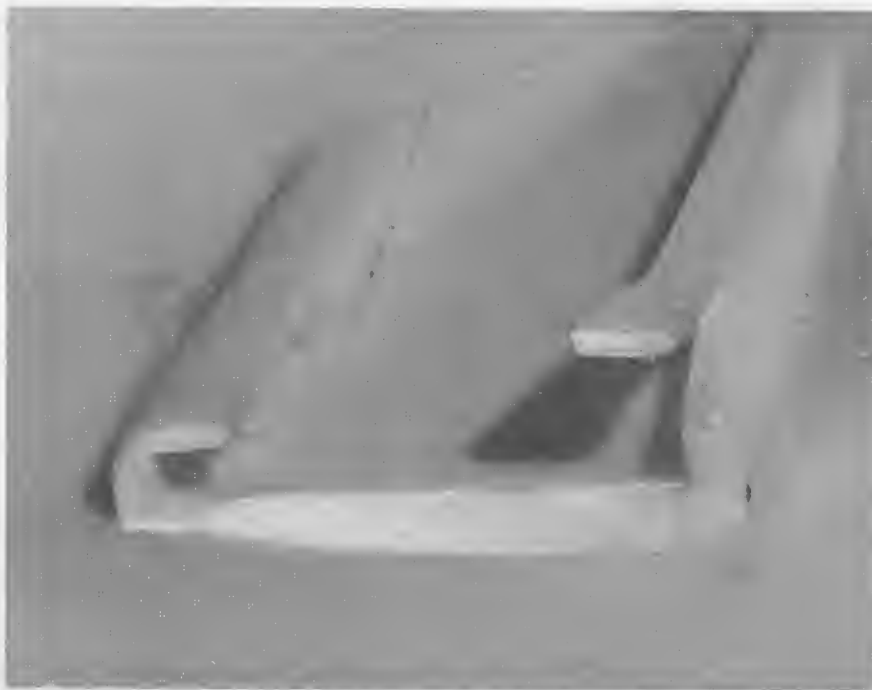
Figure 6

BROKEN HARNESS HOLDER

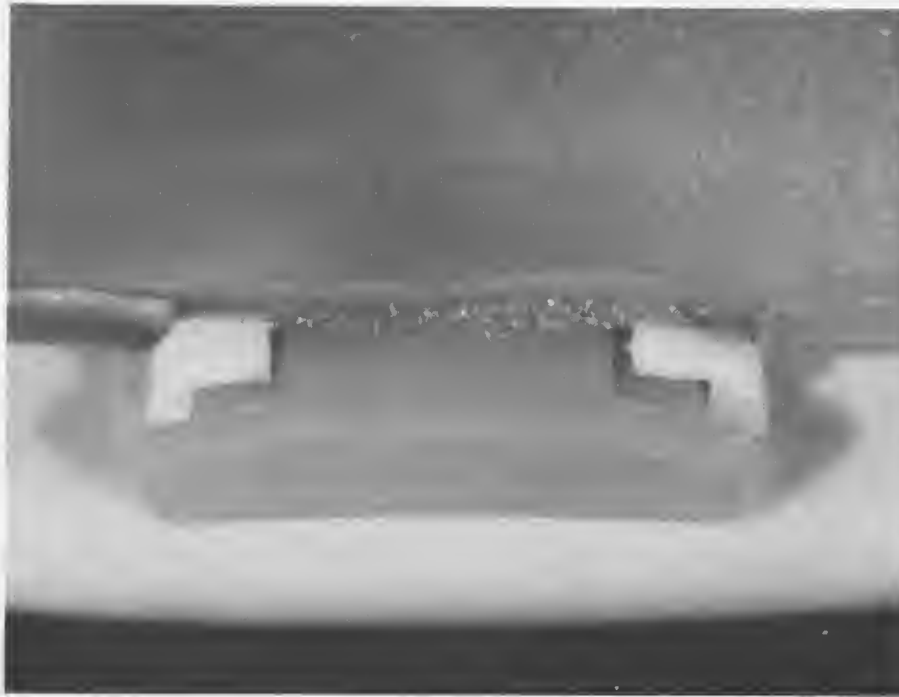
Figure 7

Examination of the headwear and the broken lug showed that the holder had extremely sharp inner corners (Figures 7 and 8) leading to the supposition that the resultant high stress concentrations may be the cause.

HARNESS HOLDER WITH HARNESS INSERTED

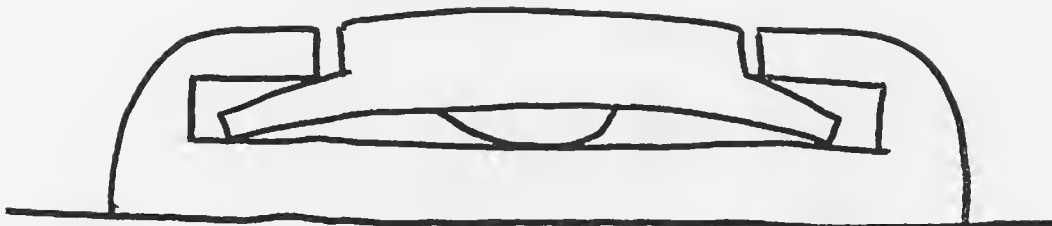
Figure 8

Because the nylon head harness is an interference fit in the holders, (Figures 3, 7, and 8) Mr. Lami and Mr. Bowan suspected that the right hand holder on the corresponding insert was oversize, resulting in overloading. They asked for my help in measuring the various parts to determine if their suspicions as to size were correct.

SKETCH OF HARNESS HOLDER SHOWING INTERFERENCE FIT

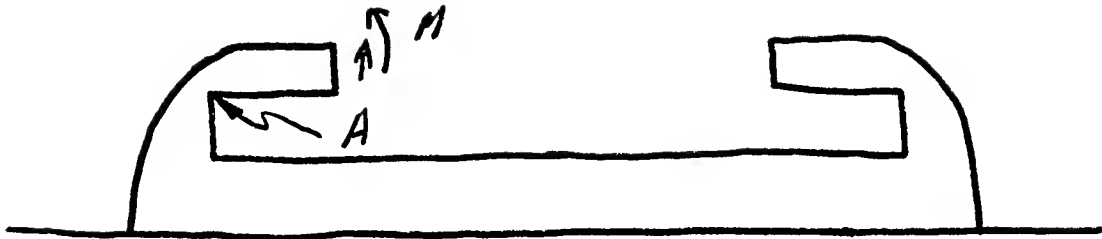
Figure 1

The failures, in all samples examined, originated at the inner corner (Point A, Figure 1). The fracture surfaces had a brittle appearance without any suggestion of ductility.

In service, the holders are loaded by insertion of a suspension attachment into the holder, (Figure 2). The geometry of the suspension attachment causes an interference fit which produces a bending moment and shear on the ears of the holder (M in Figure 1). This interference fit subjects the holders to a constant load throughout its life. During insertion, the button on the attachment is often sheared giving considerable variation in actual load. During the life of the element cold flow can be expected to reduce the loads due to the interference fit.

The geometry of the element is such that the section is thinnest at A as well as having a sharp re-entrant corner. Therefore, not only would the stress be maximum at the thin section but the sharp corner would give rise to stress concentrations of considerably greater than three (Figure 3). In addition, these stresses would be polyaxial.

The lugs failed in static fatigue due to the high stresses induced in the re-entrant corners.
